TEST REPORT

REPORT NO. : HV-17-05989 PAGE : 1 OF 3 REPORT DATE : Oct. 24, 2017

<u>Product Name</u>: Anti-Explosive Lamp

Salt Spray Test

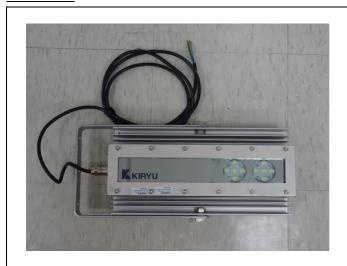
Test Sample

Test Item(s)	Test Result(s)
Salt Spray Test	No rusting, No blister and No peeling.
